SUBJECT: ON-SCENE COORDINATOR'S REPORT - Removal Action at the Dayton Tire and Rubber Co. Site, Phase II and III, Dayton, Montgomery County, Ohio (Site ID # 9A)

ON-SCENE COORDINATOR'S REPORT

**DAYTON TIRE AND RUBBER COMPANY
PHASES II AND III
DAYTON, OHIO**

DELIVERY ORDER NO. 7460-05-107

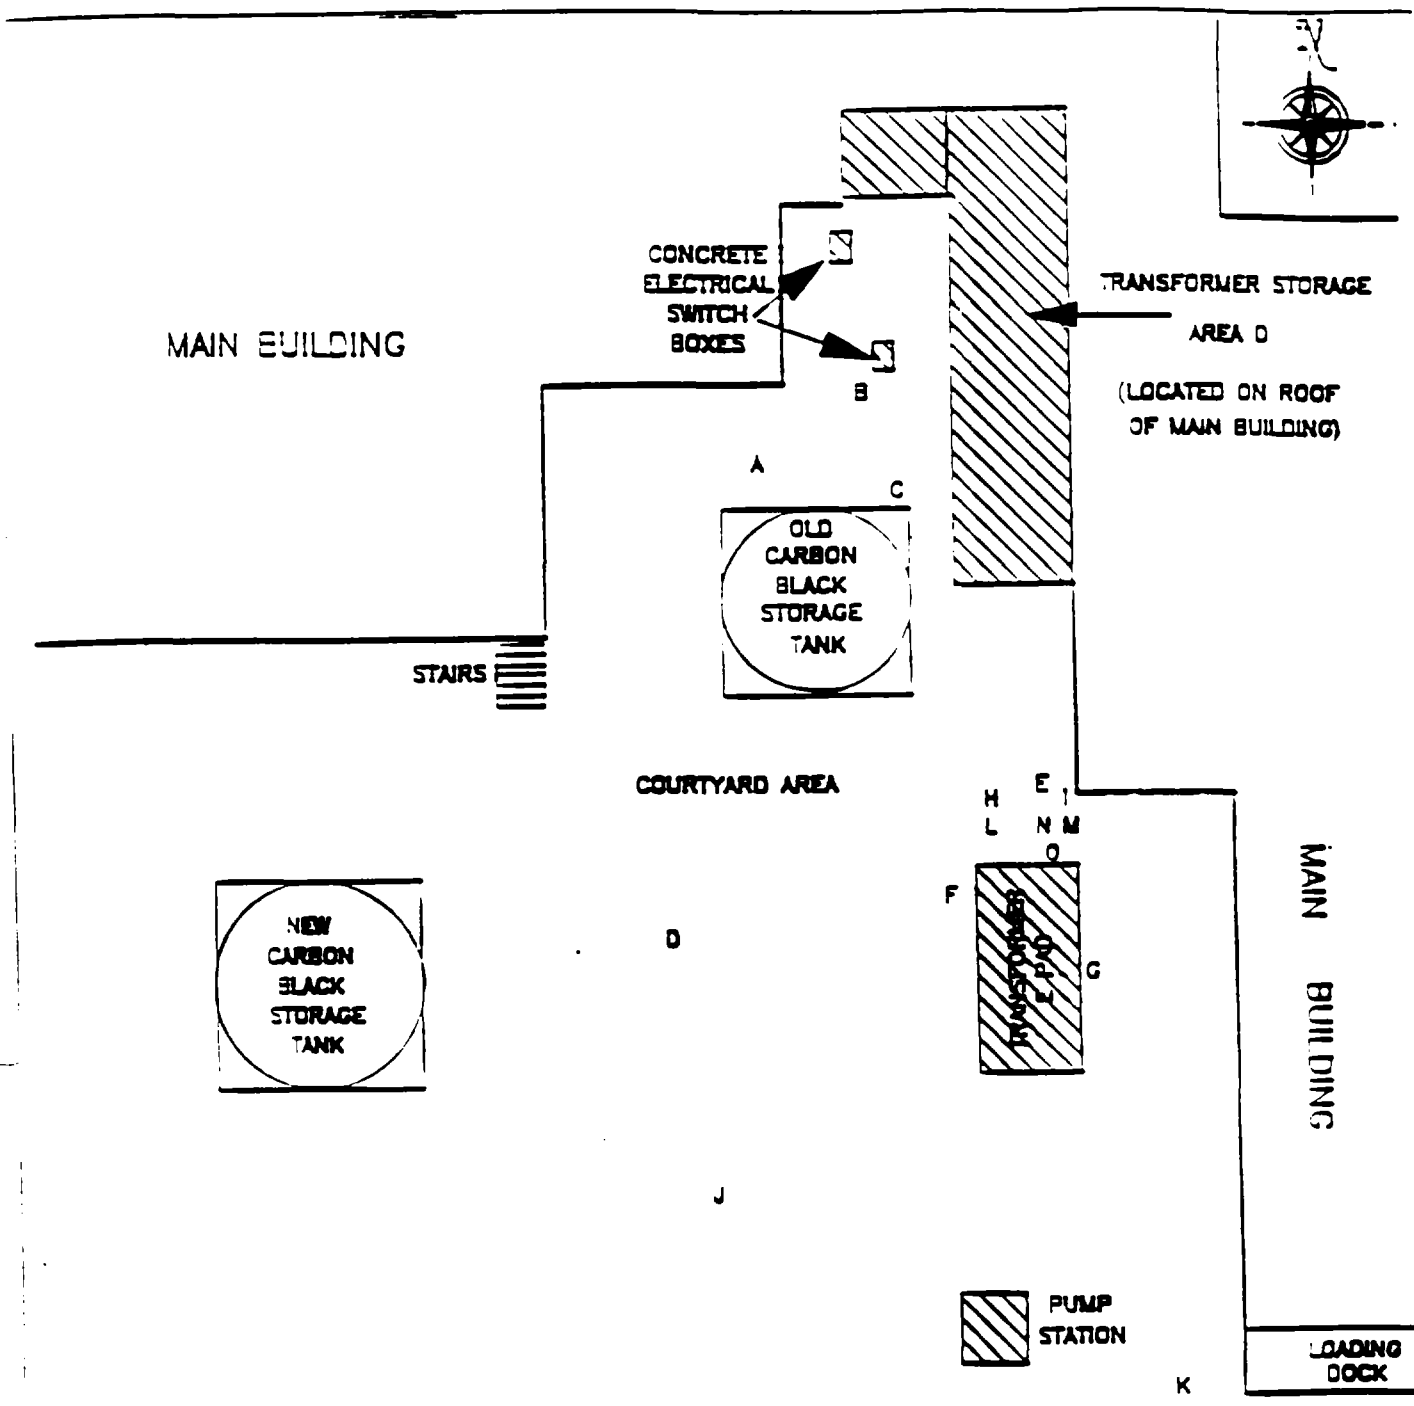
FIGURE 5

The courtyard area (located on the south side of the main building) was documented to contain elevated levels of PCB contamination in soils, concrete, and building materials as

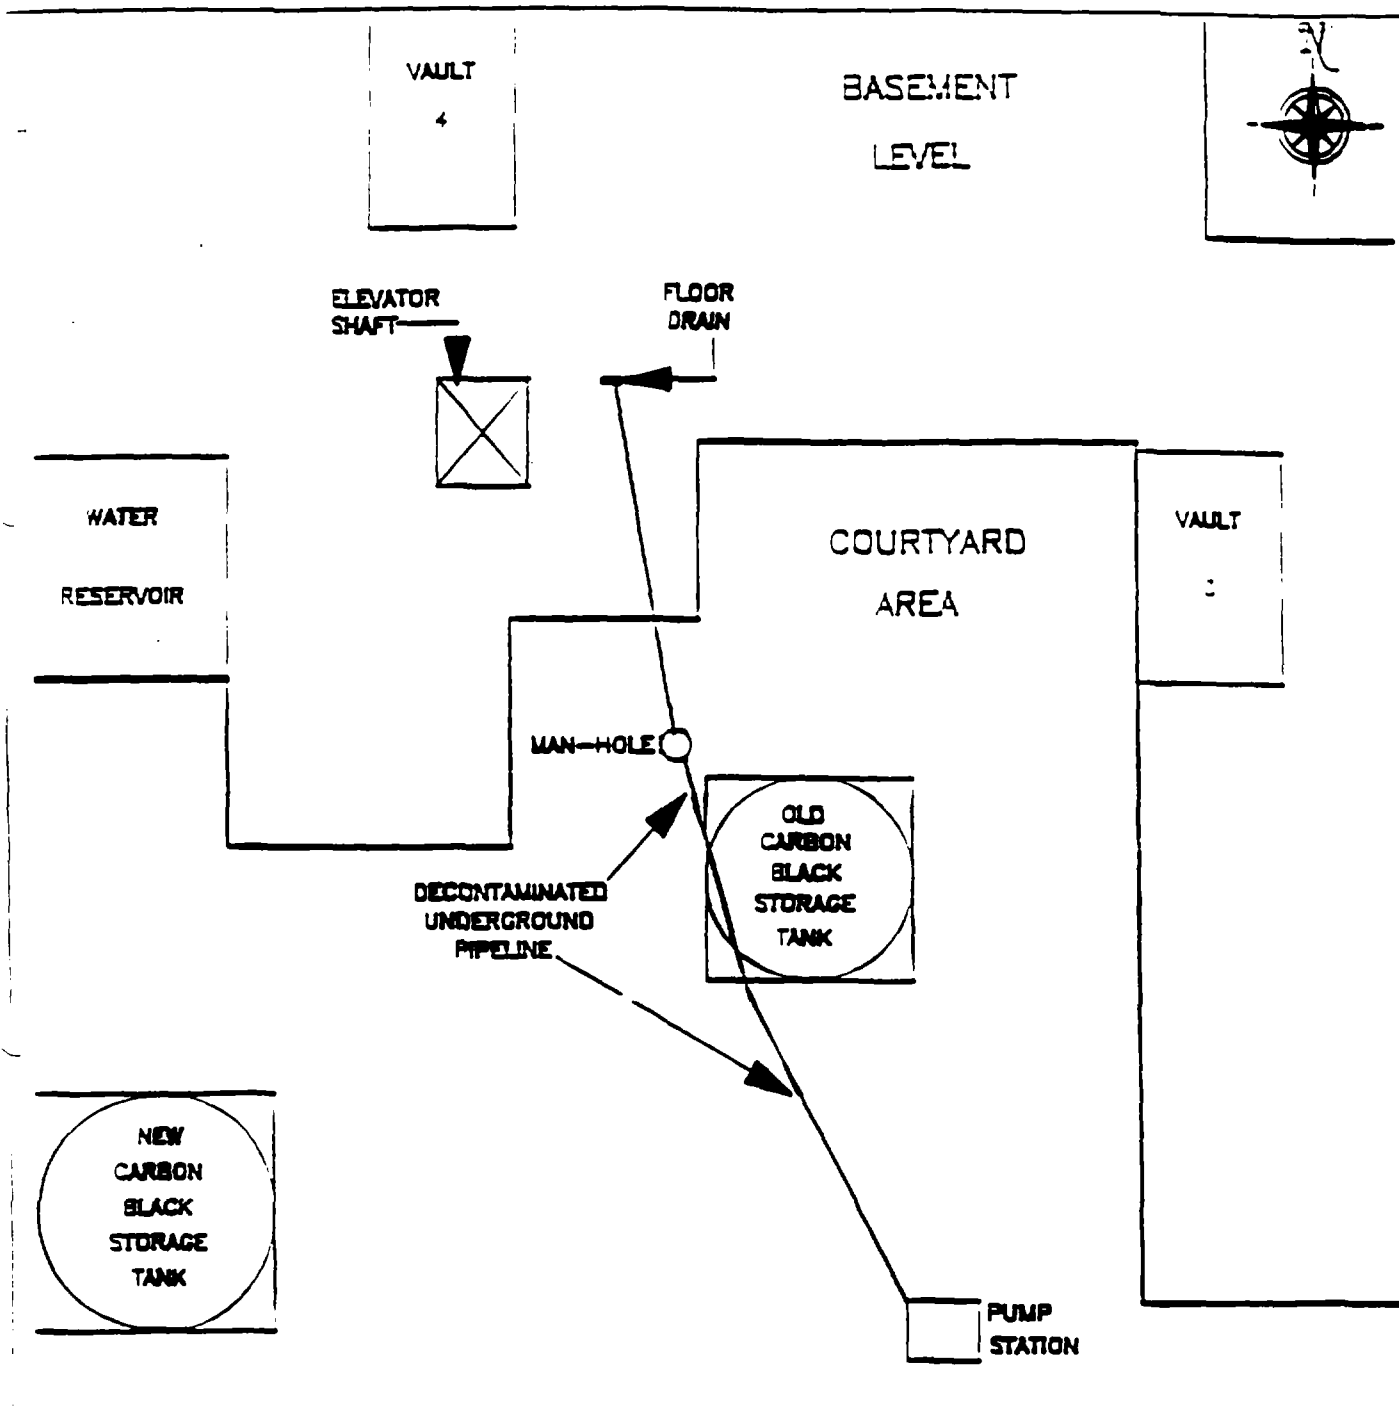
Between April 10 and 11, 1989, a 24-inch underground storm sewer drainpipe was decontaminated by Bel-Par, a cleanup subcontractor to PEI. The drainpipe extended approximately 525 feet from a large basement floor drain (located on the east side of the elevator shaft, south of Vault 4) to the site of the former pump station (Figure 6). Contamination of the drainpipe occurred when PCB-contaminated oil spilled from Vault 4 and was transported to the floor drain during basement flooding episodes (PEI, 1988). A manhole cover located on the northwest corner of the old carbon storage tank (Figure 6) provided access to the drainpipe. Using
